# 2017 Department of Defense — Allied Nations Technical Corrosion Conference

Paper No. 2017-947841

## LASER ABLATION - CORROSION REMOVAL AND ADHESION IMPROVEMENTS

Susan L. Sprentall, Founder & CEO SurClean, Inc.

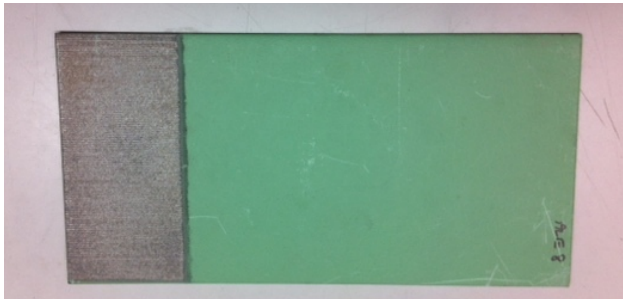
**Figure 3**  
**Navy primer on steel, back side of non-skid**

Additional passes were taken without the process control engaged. Visible damage took place to the surface, as seen on the right side of Figure 3. The pass with the process control provided a clean textured surface.

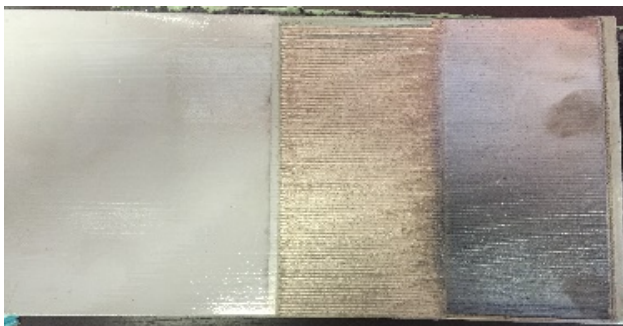
**Figure 4**  
**Control/ no control**

A nonskid stack sample was also provided. The team believed they failed when the coating could not be fully removed, Figure 4. However, the NRL staff observed, an opportunity and possible alternative to water blasting when required to clean the deck at sea.

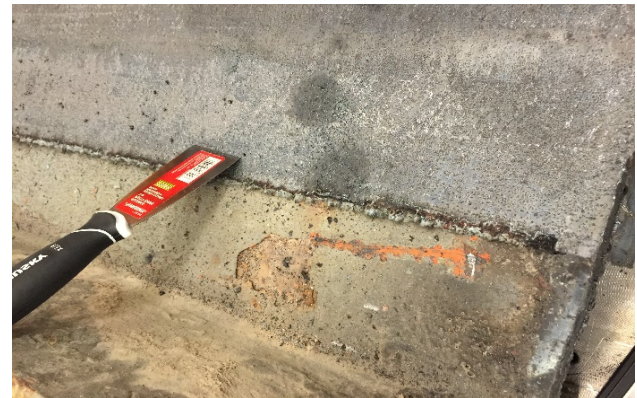
**Figure 5**  
**MDOT Sample Pass 1**

The Michigan Department of Transportation were excited to learn how laser ablation is contained at the source of removal and has the ability to prevent corrosion. The MDOT Research and Development Team sent in samples of steel I Beams, flat panels used for repair and other samples they found in the yard that had been coated with all types of lead based paints and zinc primers. First pass of the corroded samples resulted in a very clean sample (Figure 5) and it took less than one minute utilizing the exact same set up as used for the Navy samples.

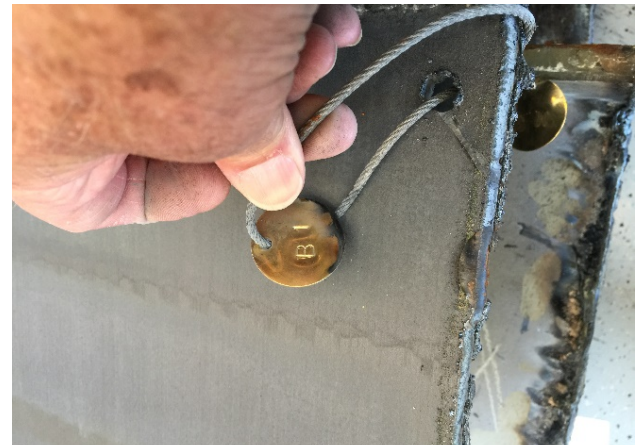
**Figure 6**  
**MDOT sample mid process**

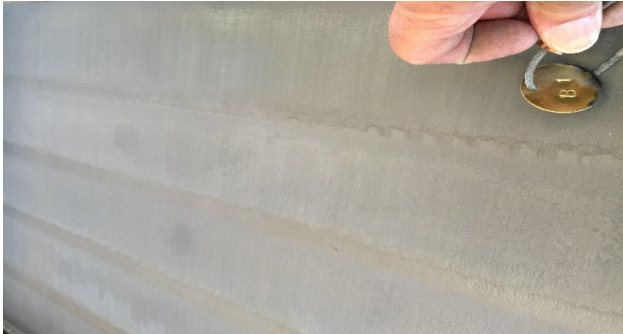
**Figure 7**  
**MDOT sample completely cleaned**

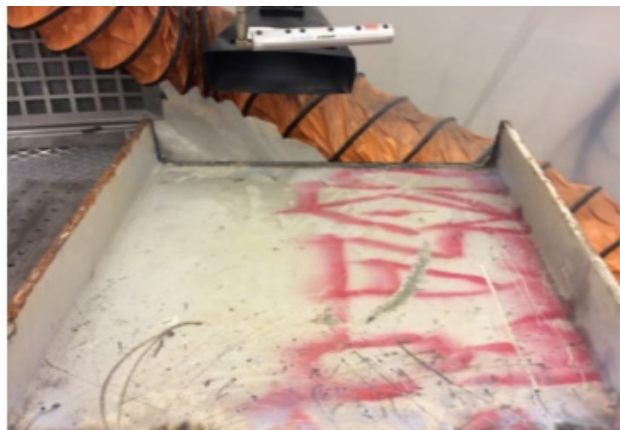
**Figure 8**  
**H2**

The previously completed Phase 1 involved the laser removal that occurred on those pieces labeled H2 (Figures 8, 9, 10), B1 (Figures 11, 12), and L2 (Figures 13, 14, 15, 16). The previously completed Phase 2 involved the abrasive blasting removal that occurred on those pieces labeled H1, B2, and L1. H2 Sample had existing type 4 coating system intact (zinc primer, epoxy intermediate and urethane finish). The dry film thickness averaged 17.83 mils.

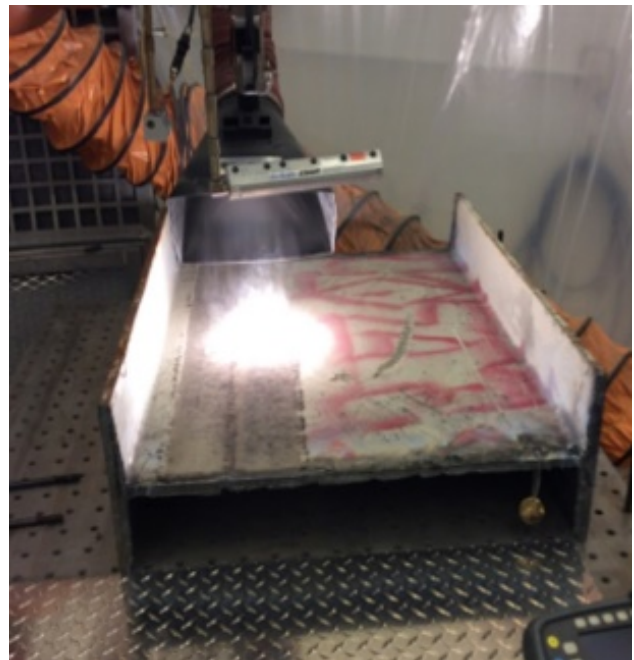
**Figure 9**  
**H2 in process**

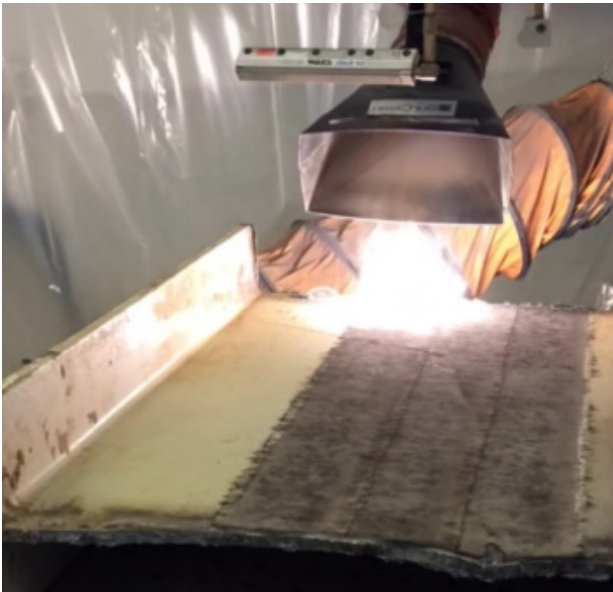
**Figure 11**  
**B1 Sample**

Sample B1 had existing type 4 coating stack (zinc primer, epoxy intermediate, and urethane finish) with high degree of visible corrosion that included holes and pitting. Dry film thickness averaged 20.14 mils prior to start. Approximately 2.5 hours of cleaning using multiple passes from a Laserline 4-kW diode pumped laser was required to remove approximately 6 square feet of paint, oxides, and debris from this sample. A surface profile of 2.2 mils was measured

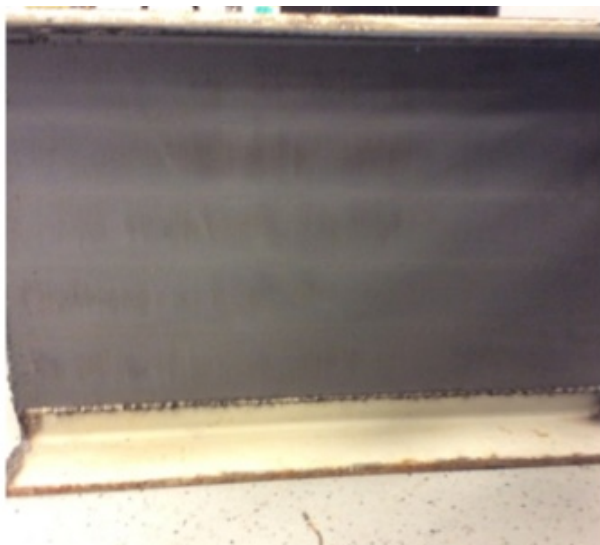
**Figure 12**  
**Completed B1 Sample**

from this substrate using X-Coarse Testex tape.

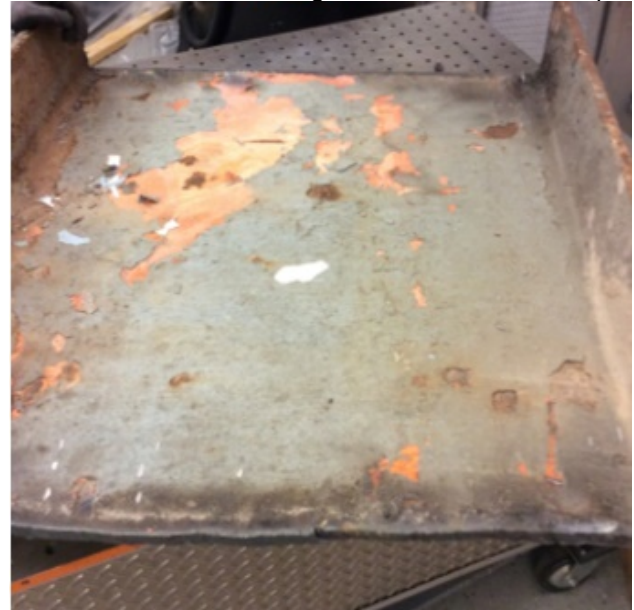
**Figure 13**  
**Sample L2**

The process continued with Sample labeled L2. This steel I-beam had been primed with lead and had many layers of various types of paints with a mil thickness average of 23.11 mils. Heavy pitting, corrosion was visible across the approximate 6 feet square area.

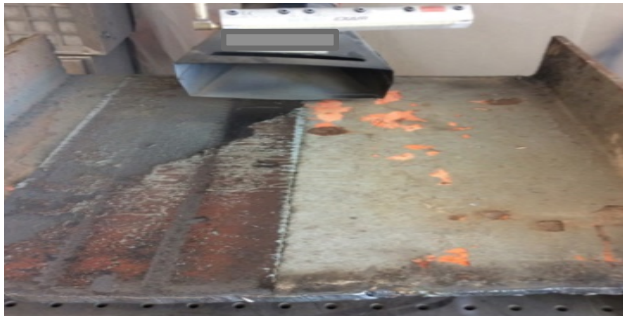
**Figure 14**  
**L2 in process**

As the machine progressed in passes, the smoke was nearly eliminated. This lead primed beam received the same amount of cleaning time that the other zinc primed beams had received, but the cleanliness of the surface was not equal. This L2 beam had many surface contaminants that could be described as fine metallic pellets/ beads / small balls, chrome and shiny in appearance, about the size of a tip of a dull pencil lead. These "balls" could be easily removed from the surface with hand tool scraping. There were however many areas of substrate that had a metallic residue or sheen that could not be removed by scraping or laser cleaning. This "residue" could be described as a tightly adhered, metallic, chrome and shiny in appearance, surface contaminant. A surface profile of 3 mils was measured from substrate using X-Coarse Testex tape.

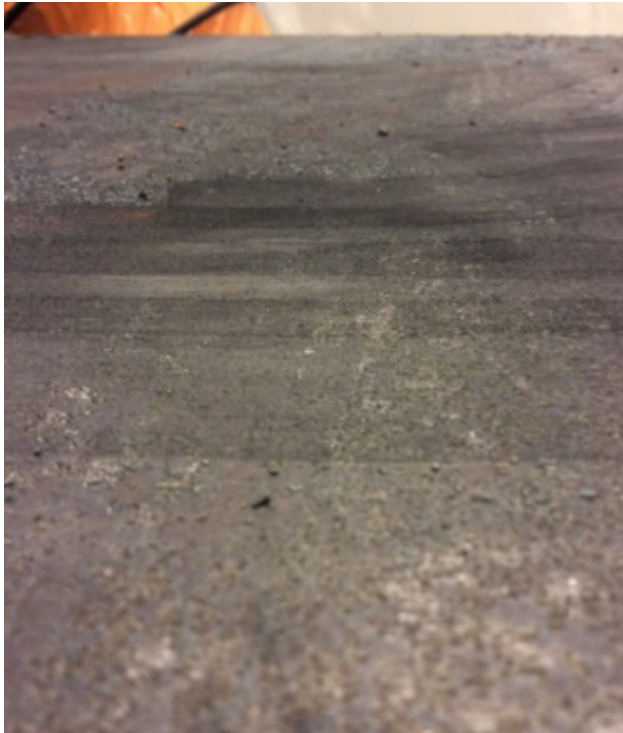
**Figure 15**  
**Surface L2**

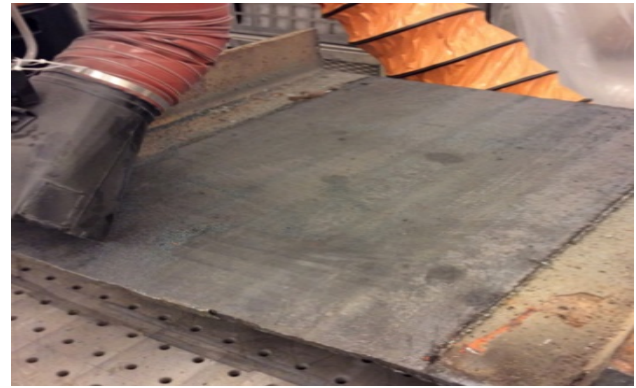
**Figure 16**  
**L2 Complete**

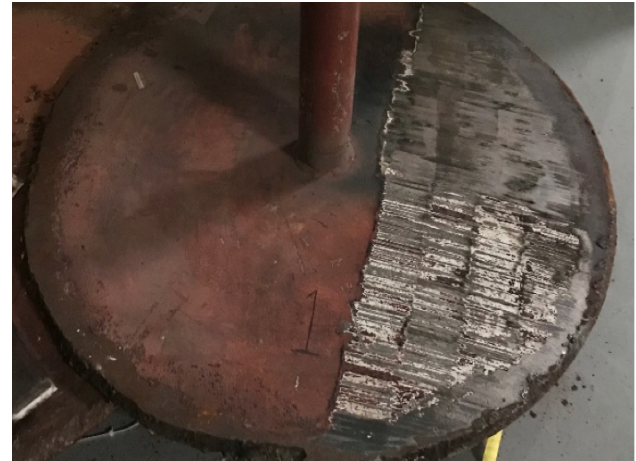
**Figure 17**  
**Heavy steel 1/2" thick curved surface plate**

The shipyard sent various sizes and shapes of samples retrieved from a salvage yard (Figures 17, 18). The prospective customer is located in the Northwest and is under heavy regulations to not deposit any contaminants in the water or soil off the Pacific Coast. Additionally, workforce attrition is an issue, and, to attract young people to the shipyard, new technology is needed.

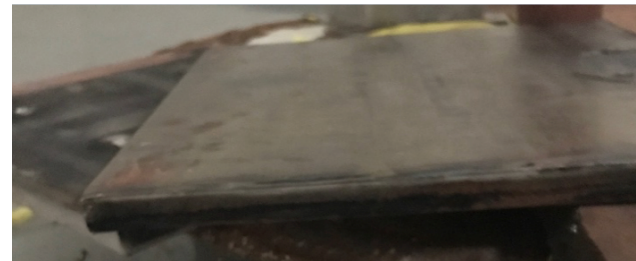
**Figure 18**  
**Flat 1" thick steel plate with paint and corrosion**

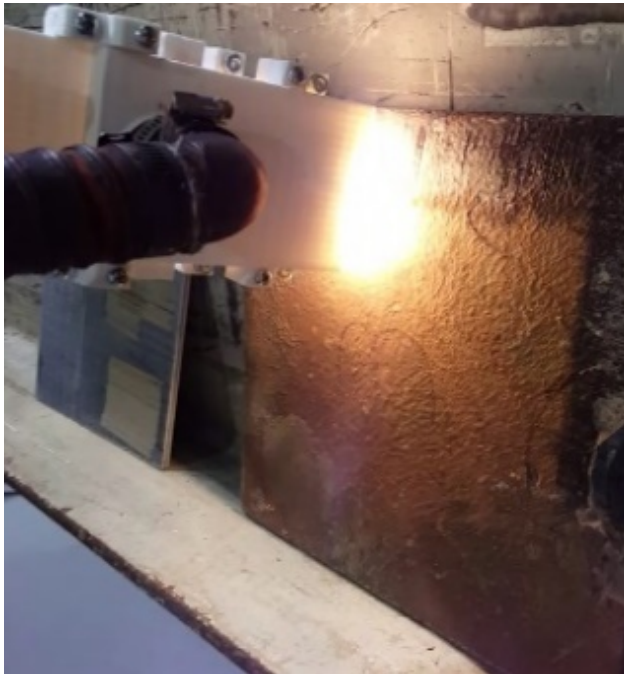
**Figure 19**  
**Sample 1 Process**

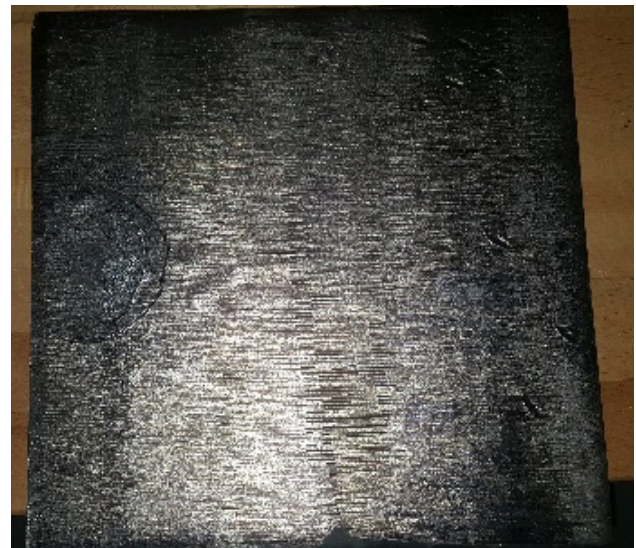
**Figure 20**  
**Sample 1 Finished**

The profile was measured and found to be within specifications at 2.75 mil. The samples were painted with the standard specified Navy 5 coat: 2 coats of primer, 2 coats of paint, and 1 coat of top coat. The samples were sent to a chamber that “ages” the paint to the equivalent of 7 to 10 years at sea - the average time for paint to start cracking and peeling.

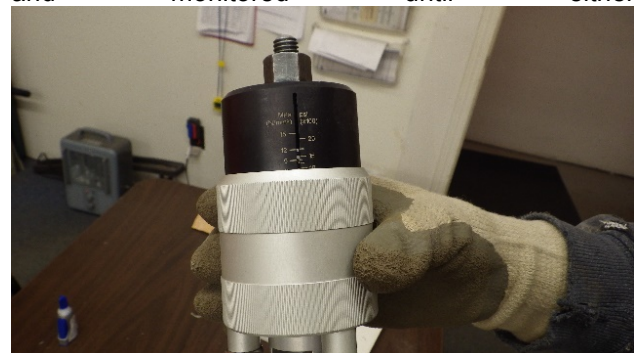
**Figure 21**  
**Paint Supplier Adhesion Tester Used**

In this case, the Elcometer 106 Adhesion Tester is easy to operate and fully portable and provides a numerical value for adhesion

At this point, the samples were returned to the shipyard quality control office. The paint supplier and shipyard QC staff conducted a paint adhesion pull test. Adhesion of a multi-coat system of paint is assessed by measuring the minimum tensile stress necessary to detach or rupture the coating in a direction perpendicular to the substrate. This method maximizes tensile stress as compared to the shear stress applied by other methods, such as scratch adhesion, and results may not be comparable. The test is performed by securing a loading fixture (dolly) perpendicular to the surface of the coating with an adhesive. After the adhesive is cured, a testing apparatus is attached to the loading fixture and aligned to apply tension perpendicular to the test surface. The force applied is gradually increased and monitored until either

a plug of coating material is detached, or a specified value is reached. The normal range acceptable is 385 psi to 400 psi after a ship has been sandblasted, water jet washed, profile checked, and repainted. In some cases, and in some locations on the vessel, 325 psi will pass. These are considered great ratings.

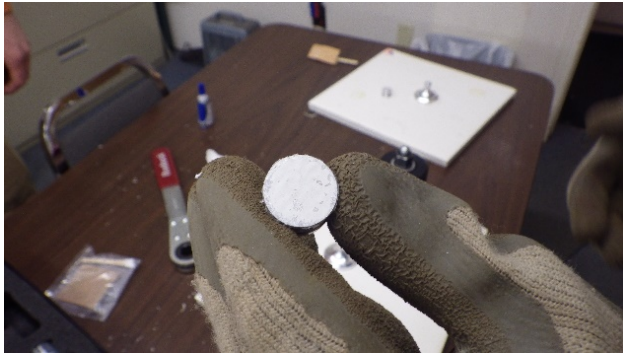
**Figure 22**  
**Paint Supplier-Dollie separated from glue bond**

After the initial testing was completed, the lab was informed of the results reaching 1400 PSI. At this point the test dollie separated from the glue bond and not the coating separating from the glue bond with the dollie which is normal in most testing cases.

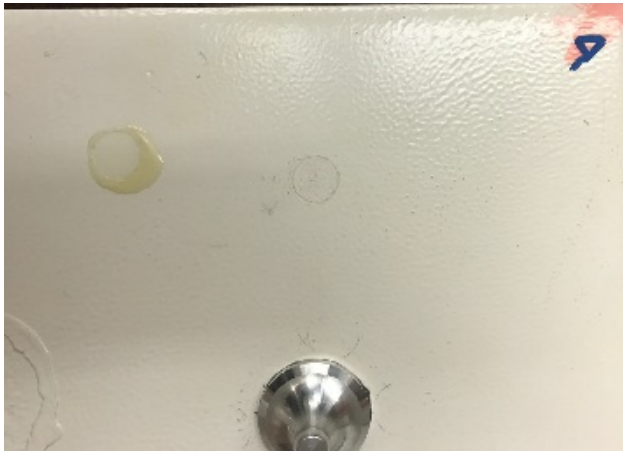
**Figure 23**  
**Sample after Paint Supplier Pull Test**

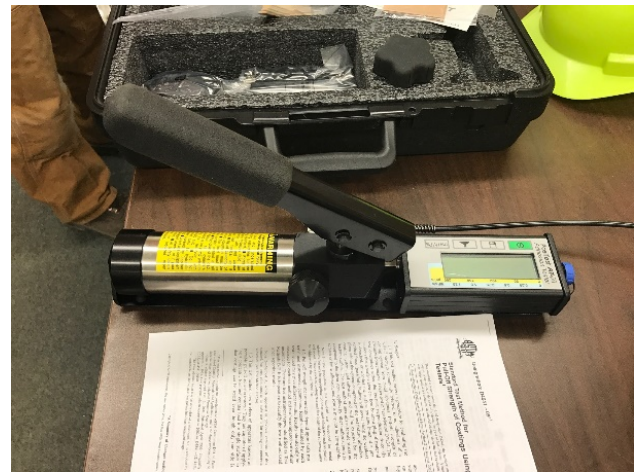
The PosiTest Adhesion Tester measures the force required to pull a specified test diameter of coating away from its substrate using hydraulic pressure. The pressure is displayed on a precision digital indicator and can be related to the strength of adhesion to the substrate.

**Figure 24**  
**Shipyard Hydraulic Pressure Digital Readout**

The adhesion test was performed again on the same samples utilizing the shipyard equipment and receiving almost identical results 1380 psi.
